MT. CRESTED BUTTE WATER  
AND SANITATION DISTRICT  
TIMBERLAND TANK RING WALL REPAIR

CONCRETE RINGWALL  
PLAN & SECTION

## SUPPLEMENTAL INFORMATION

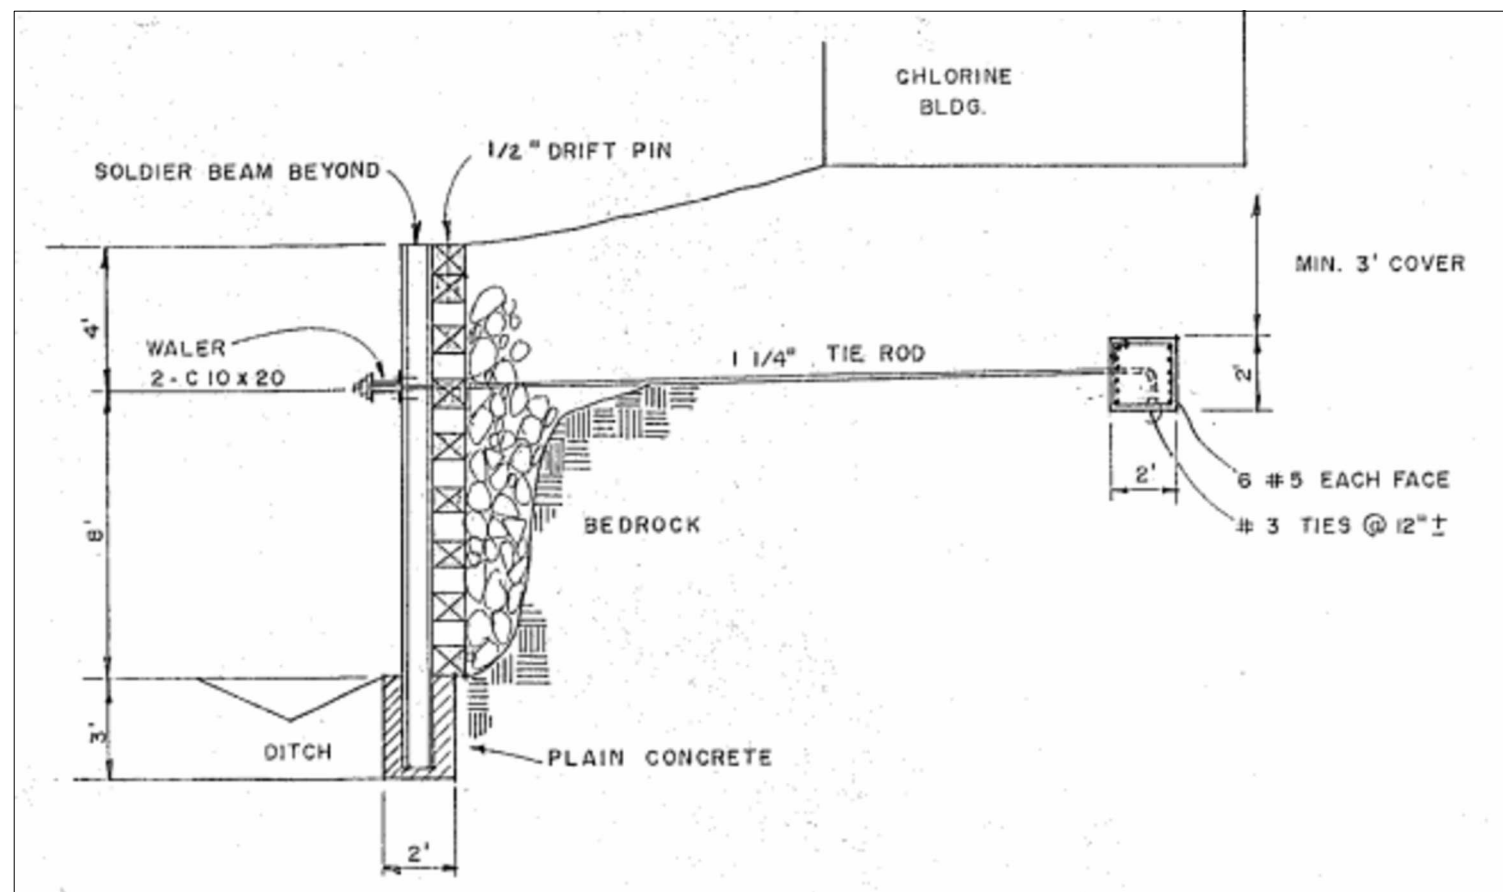
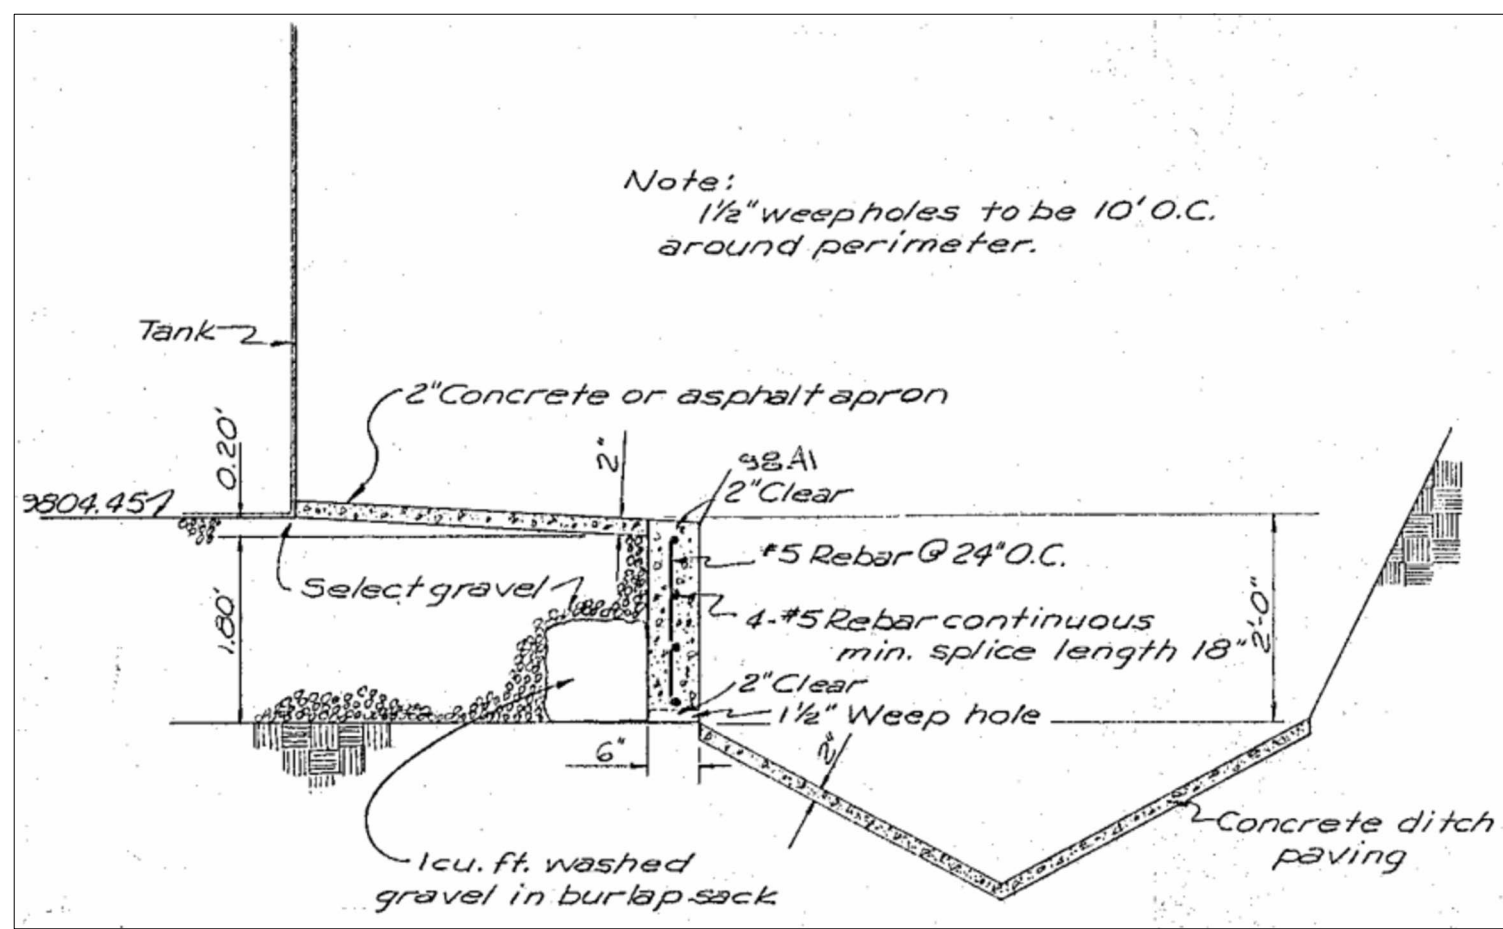
1  
-  
EXISTING RINGWALL DETAIL  
NOT TO SCALE

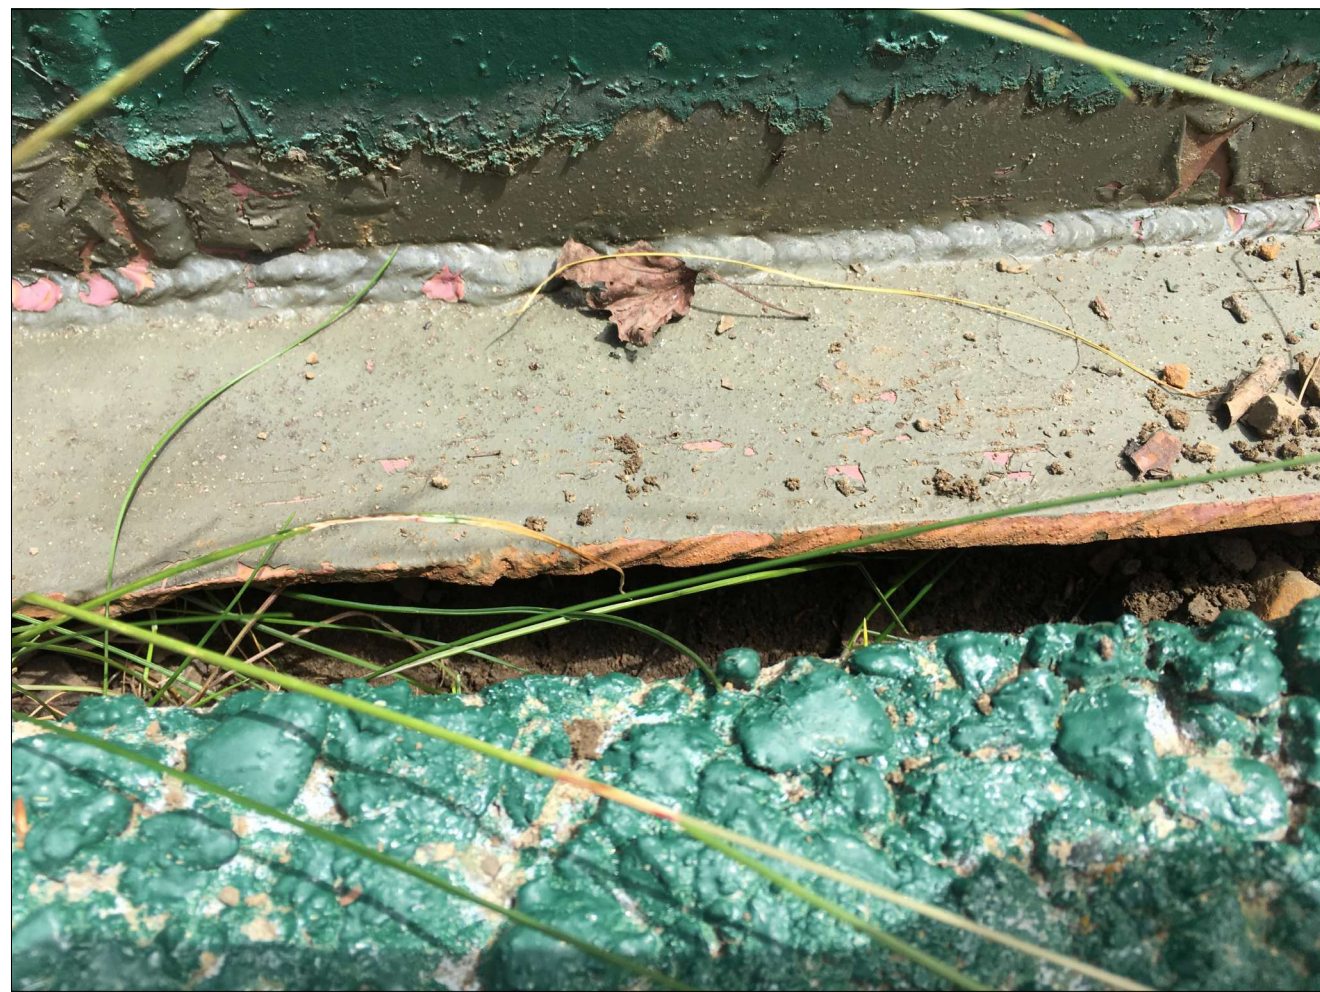
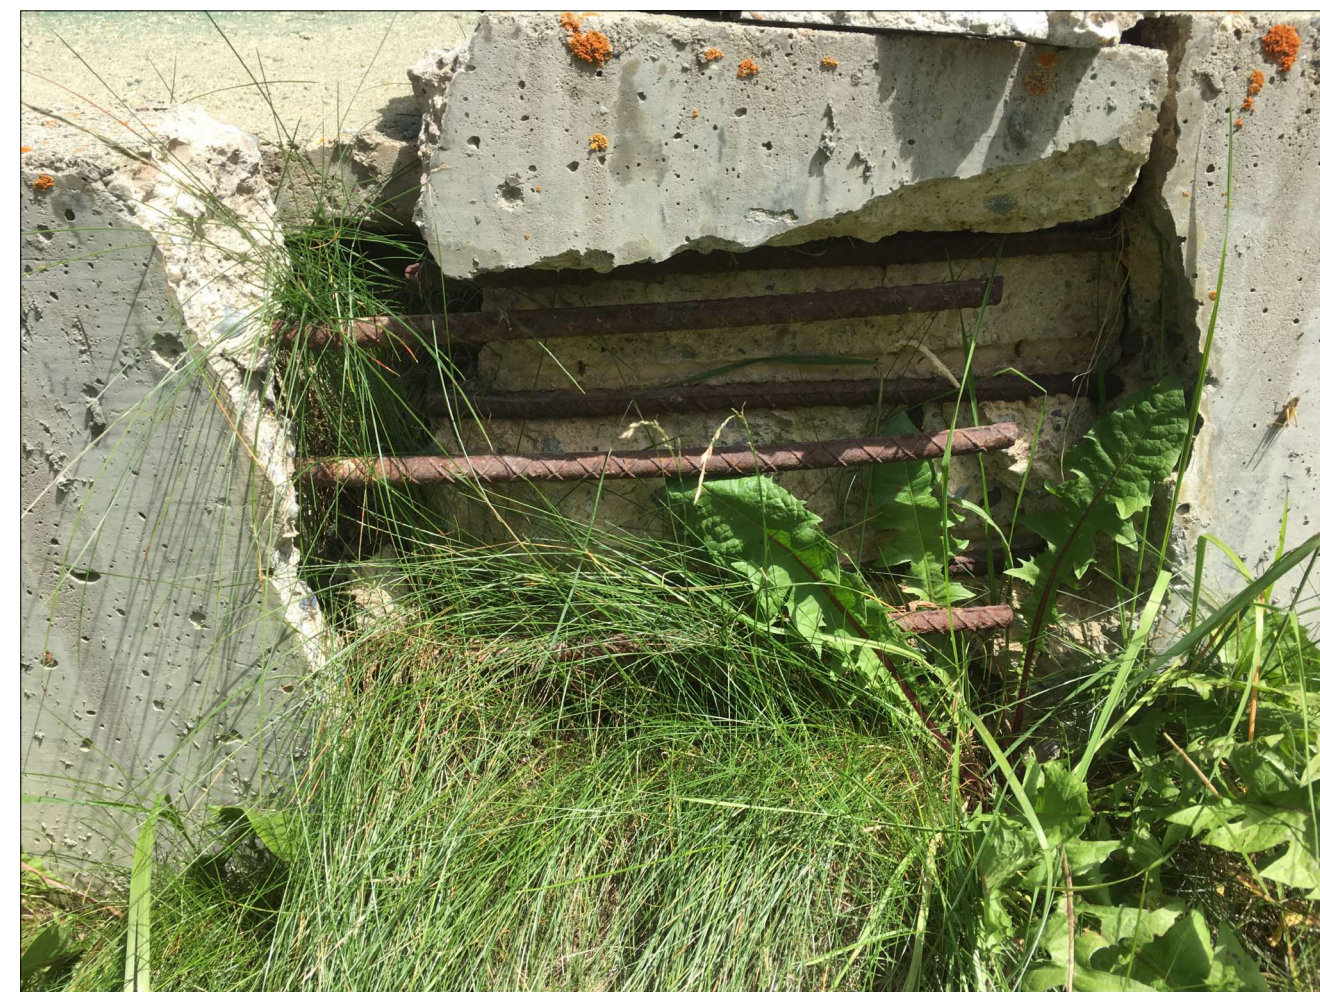
2  
-  
EXISTING RINGWALL PICTURES  
NOT TO SCALE

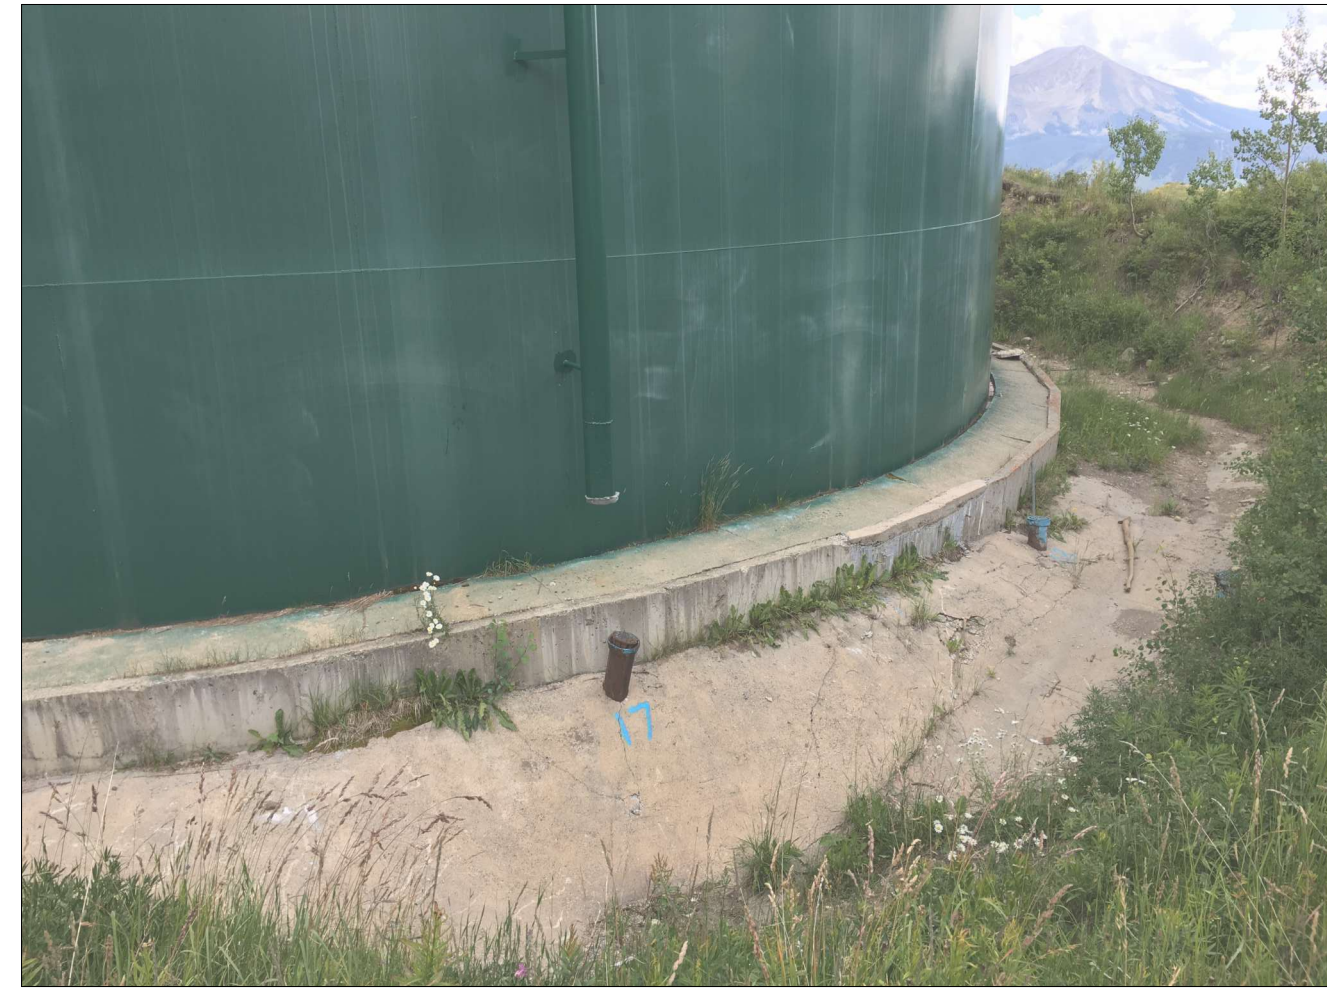
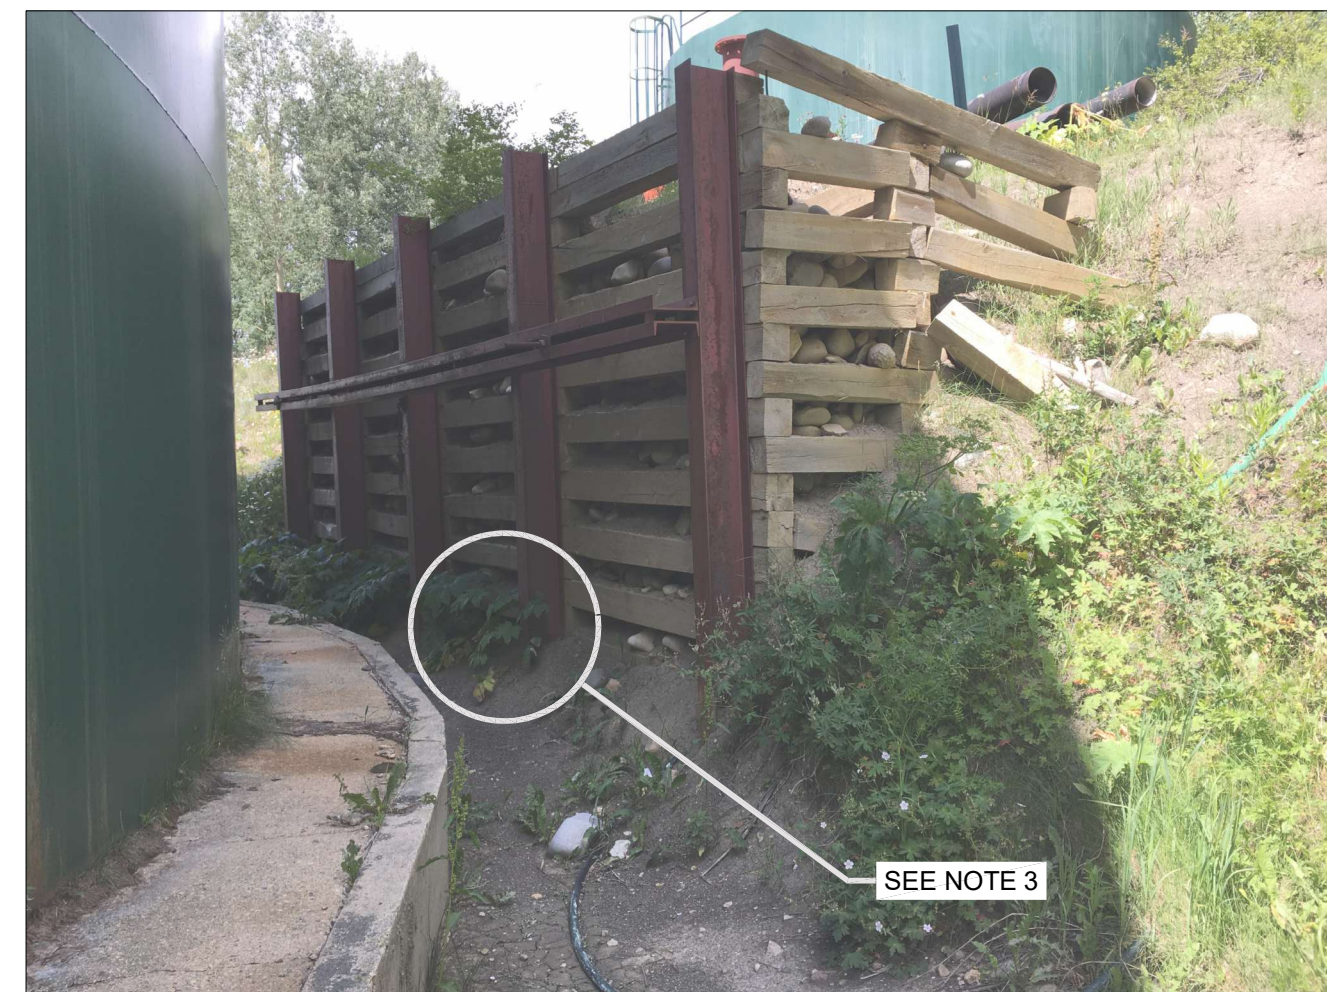
3  
-  
EXISTING RINGWALL AND RETAINING WALL PICTURES
